RESOLUTION AUTHORIZING THE PAYMENT FOR VEHICLE LOSS FOR ANGELA VINE

RE: Insured	Village of Caledonia
Claimant	Angie Vine
Date of Loss	2/17/19
My File#	CL021719C

LOSS ASSIGNMENT SUMMARY

VEHICLE EVALUATION FORM

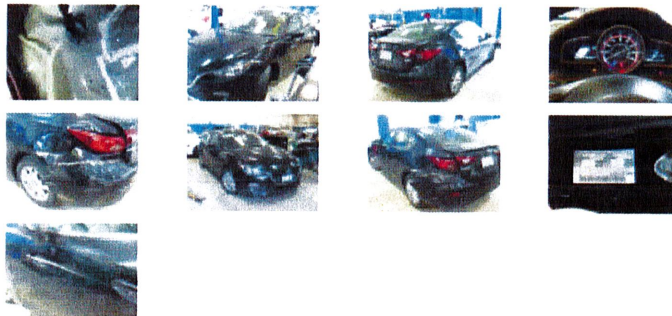
Vehicle Images

The initial area of impact was to the left rear of the vehicle. Initial impact caused moderate damage to the left inner and outer quarter panel, taillight, deck lid and rear bumper cover. Secondary damages where to the driver's door where a gash caused by the snow blade cut into the outer panel. There is a code stored in the vehicle module however what has triggered the code is unknown at this point. I am suspect it is related to the incident.
